St James' Church, Wick

PROJECTS

2018 - 2021

Projects 2018-2021

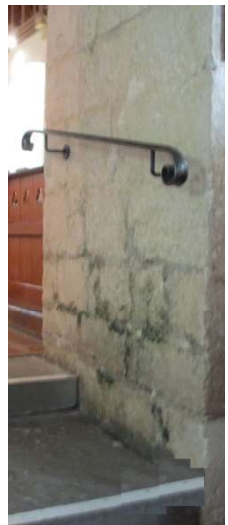
We were conscious of two potential hazards – the steps beneath the chancel arch and the plinth beneath the font, which had caused people to trip up.

For the chancel steps, the decision was to install handrails, but these would need to take account of the position, minimising the impact on the 12th century arch. The task was entrusted to Paul Dennis, a specialist in architectural metalwork.

The hand-crafted brackets supporting the handrails have history. They originally formed part of the Albert Memorial in London, but were no longer required after a major restoration of the memorial in the 1990s. The Albert Memorial was completed in 1872, around the time of the Victorian restoration of St James' Church.

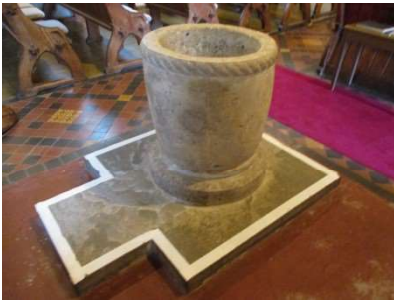
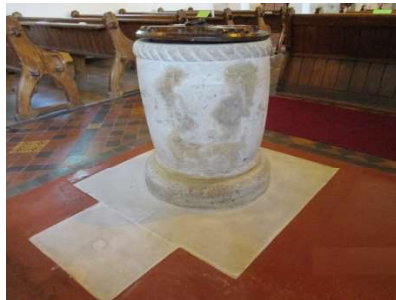
The font dates from Norman times, but the plinth was probably Victorian. Unfortunately, it was damaged when it was raised and has now been replaced with new stone, which is set flush with the surrounding floor.

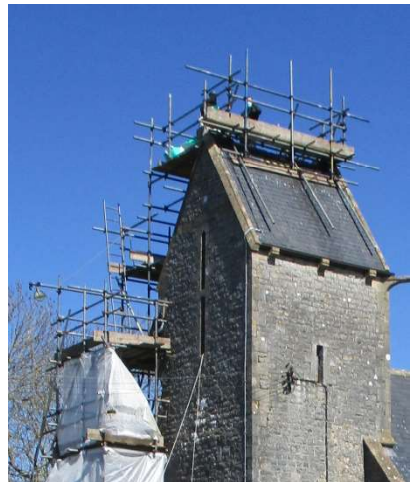
Repairs to the tower took place at the same time as the repointing of the chancel walls. We had commissioned a report from a structural engineer, who advised that the problems identified in a 2006 report (such as cracks permitting water ingress into the walls, potentially causing subsequent damage, damp issues internally, etc) had not been resolved. In keeping with the engineer's recommendations, to avoid matters getting worse, the crack was repaired with stainless steel reinforcing bars, damaged facing stone made good by piecing in new stone and the north face of the tower repointed.

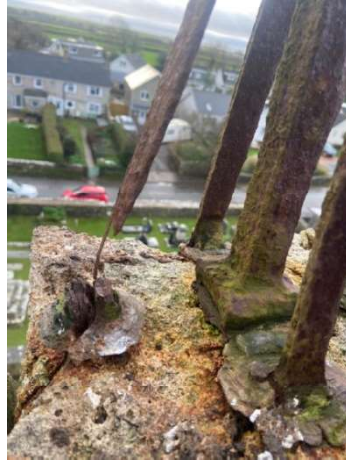
While repairing the lightning conductor, we found various other problems with the tower roof. The metalwork was corroded, the coping stones needed repointing and the bell supports inside were dangerously fragile. While we had run out of funds at this stage, these were things that really needed to be dealt with while the scaffolding was in place.

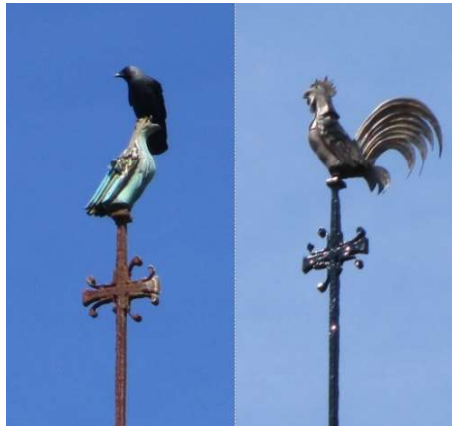
No one was very sure what sort of bird was sitting on top of the finial. It had become a perch for other birds. The shape was found to be consistent with a cockerel, but he had lost both head and tail over the past 150 years. The original hard wood form and copper coating was all kept and simply added to in order to restore the cockerel to his former self. And, as a weathercock, he now turns in the wind.

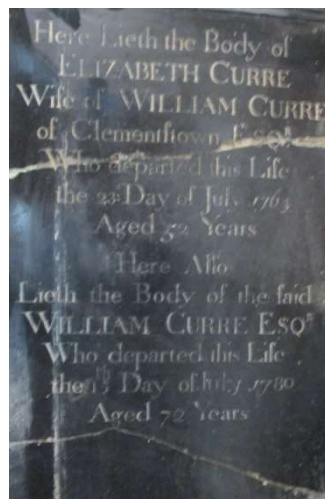
The memorial obscured by the altar base

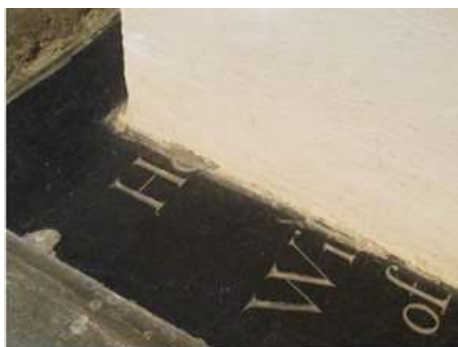
There was a problem with damp where the altar was joined to the wall

As part of tacking the damp, it was agreed to move the mediaeval stone mensa away from the east wall and mount it on new stone supports. This had the added advantages of allowing west-facing celebration of the Eucharist and uncovering a memorial.

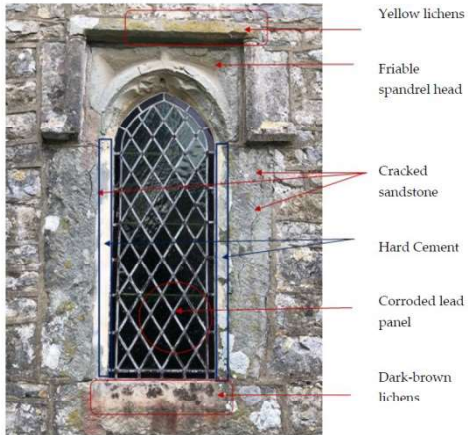
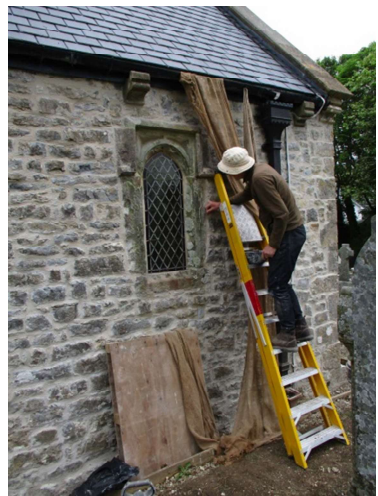
The stonework around the window, said to date from the 13th century, was in poor condition and previous efforts at repair had not helped. The conservators undertook repairs so as to limit further problems.
